**Flood Control Project Maintenance
Levee Inspections**
LMA District Cover Sheet
Spring 2018 Levee Inspection Results

Tehama County Flood Control and Water Conservation District

Spring 2018 Levee Inspection Results

Waterway			Bank	Unit Miles
Unit No. 01 Deer Creek			Left	4.22
	Spring (March - May)	Summer (June - August)	(September - November) Fall	Winter (December - February)
Unit Maintenance Rating (Fall Only)				
Date of Inspection	4/4/2018 - 4/4/2018			
DWR Inspector	Bob Duffey			
Accompanied By	Ryan Teubert Tehama County

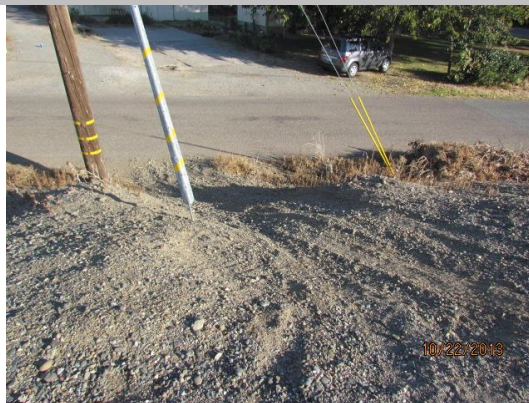
Photo 1 of 1 : SP_2018_NA0019_81_12_20180305_00007.jpg

View of the slope instability caused by vehicles along the landside slope.

LM Start	2.32	Rating **	M	Issue No.	12
LM End	2.32	Issue Type +	Ma	Location *	LS
Category	Earthen Levee			GPS Latitude/Longitude	
				Start	End
Item	Slope Stability			40.052443 °	40.052443 °
				-122.148863 °	-122.148863 °
DWR ID	DWR_NA0019_04_f_2013_12				
Comment Code					
S3 : Repair the levee slope damaged by vehicle traffic and prevent access where possible.					
Inspector Comment

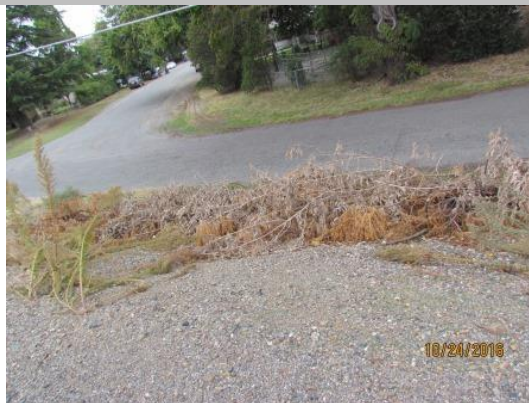
Photo 1 of 1 : SP_2018_NA0019_81_31_20180305_00019.jpg

View of the prunings along the landside toe.

LM Start	2.37	Rating **	M	Issue No.	31
LM End	2.37	Issue Type +	En	Location *	LS
Category	Earthen Levee			GPS Latitude/Longitude	
				Start	End
Item	Encroachments			40.052451 °	40.052451 °
				-122.147962 °	-122.147962 °
DWR ID	DWR_NA0019_04_f_2016_31				
Comment Code					
PR : Prunings					
Inspector Comment					
Remove prunings from the landside toe.

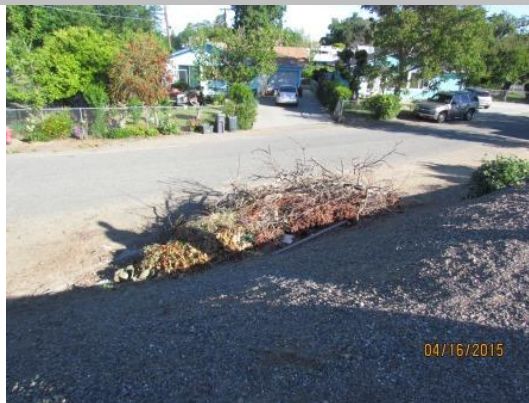
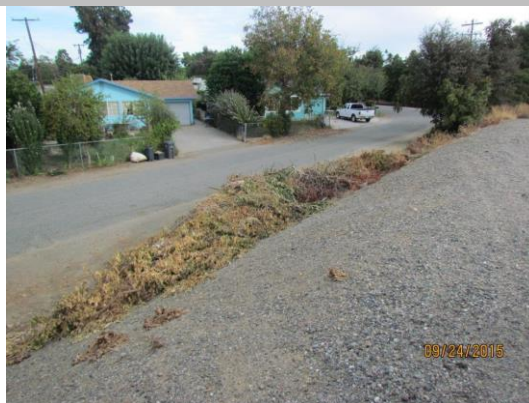
View of the prunings along the landside toe.

LM Start	2.63	Rating **	M	Issue No.	15
LM End	2.63	Issue Type +	En	Location *	LS
Category	Earthen Levee			GPS Latitude/Longitude	
				Start	End
Item	Encroachments			40.054337 °	40.054337 °
				-122.144235 °	-122.144235 °
DWR ID	DWR_NA0019_04_s_2015_15				
Comment Code					
PR : Prunings					
Inspector Comment					
Remove the prunings from the landside toe.

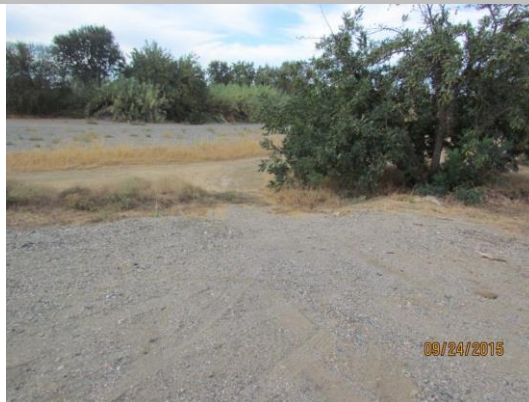
Photo 1 of 1 : SP_2018_NA0019_81_10_20180305_00006.jpg

View of the slope instability caused by vehicles along the landside slope.

LM Start	3.01	Rating **	M	Issue No.	10
LM End	3.01	Issue Type +	Ma	Location *	WS
Category	Earthen Levee			GPS Latitude/Longitude	
				Start	End
Item	Slope Stability			40.056388 °	40.056388 °
				-122.139168 °	-122.139168 °
DWR ID	DWR_NA0019_04_s_2012_10				
Comment Code					
S3 : Repair the levee slope damaged by vehicle traffic and prevent access where possible.					
Inspector Comment

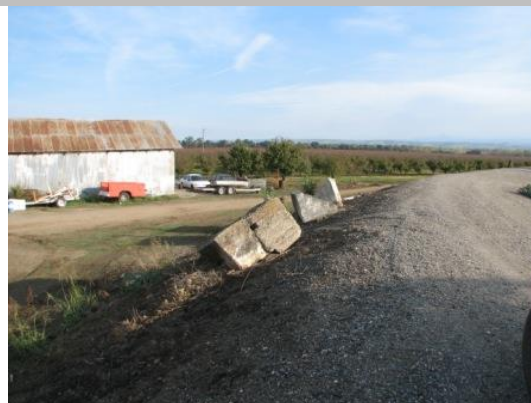
Photo 1 of 1 : SP_2018_NA0019_81_1_20180305_00001.jpg

View of the concrete stairways on the slope.

LM Start	3.11	Rating **	M	Issue No.	1
LM End	3.13	Issue Type +	En	Location *	LS
Category	Earthen Levee			GPS Latitude/Longitude	
				Start	End
Item	Encroachments			40.057083 °	40.057291 °
				-122.137935 °	-122.137743 °
DWR ID	DWR_NA0019_04_s_2012_1				
Comment Code					
DE : Debris					
Inspector Comment					
Remove concnere blocks, concrete pipes, and concrete stairs from the landside slope.

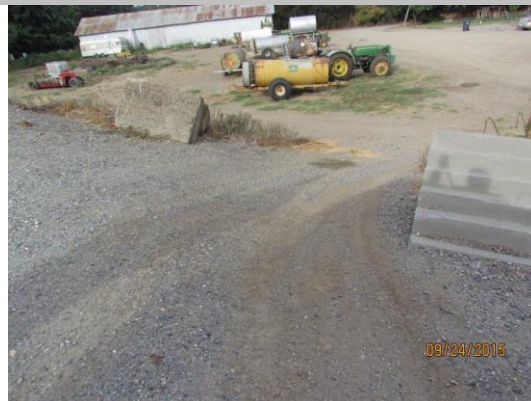
Photo 1 of 1 : SP_2018_NA0019_81_25_20180305_00015.jpg

View of the slope instability caused by vehicles along the landside slope.

LM Start	3.13	Rating **	M	Issue No.	25
LM End	3.13	Issue Type +	Ma	Location *	LS
Category	Earthen Levee			GPS Latitude/Longitude	
				Start	End
Item	Slope Stability			40.057350 °	40.057350 °
				-122.137667 °	-122.137667 °
DWR ID	DWR_NA0019_04_f_2015_25				
Comment Code					
S3 : Repair the levee slope damaged by vehicle traffic and prevent access where possible.					
Inspector Comment

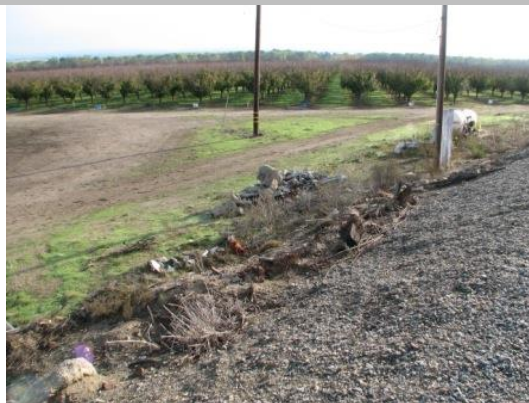
Photo 1 of 1 : SP_2018_NA0019_81_6_20180305_00005.jpg

LM Start	3.31	Rating **	M	Issue No.	6
LM End	3.31	Issue Type +	En	Location *	LS
Category	Earthen Levee			GPS Latitude/Longitude	
				Start	End
Item	Encroachments			40.057558 °	40.057558 °
				-122.134417 °	-122.134417 °
DWR ID	DWR_NA0019_04_s_2012_6				
Comment Code					
GA : Garbage					
Inspector Comment

View of the garbage and metal along the landside slope and toe of the levee.

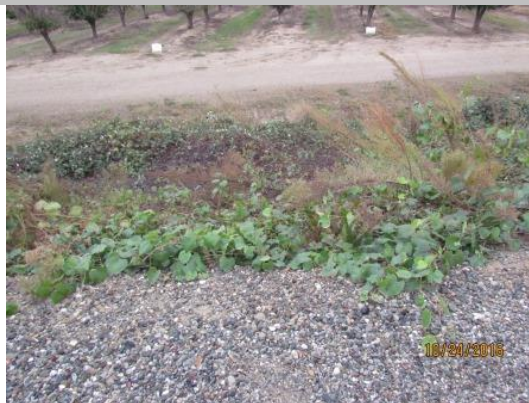
Photo 1 of 1 : SP_2018_NA0019_81_39_20180305_00022.jpg

View of the blackberries along the landside slope blocking visibility and access.

LM Start	3.40	Rating **	M	Issue No.	39
LM End	3.44	Issue Type +	Ma	Location *	LS
Category	Earthen Levee			GPS Latitude/Longitude	
				Start	End
Item	Vegetation			40.056546 °	40.055906 °
				-122.133530 °	-122.133294 °
DWR ID	DWR_NA0019_04_f_2016_39				
Comment Code					
V2 : Remove the wild growth other than native grasses from the levee slopes.					
Inspector Comment

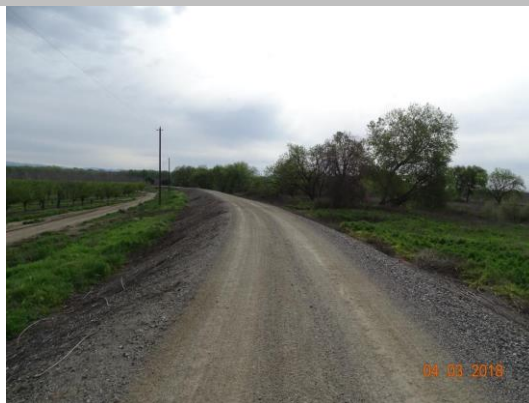
Photo 1 of 1 : SP_2018_NA0019_81_52_20180405_00080.jpg

LM Start	3.52	Rating **	A	Issue No.	52
LM End	3.52	Issue Type +	Ma	Location *	LS
Category	Earthen Levee			GPS Latitude/Longitude	
				Start	End
Item	Vegetation			40.055347 °	40.055347 °
				-122.132130 °	-122.132130 °
DWR ID	DWR_NA0019_04_s_2018_52				
Comment Code					
V1 : Control annual grass and weeds on the levee slopes and easements.					
Inspector Comment					
The vegetation was removed from both slopes.

View of no vegetation on both slopes.

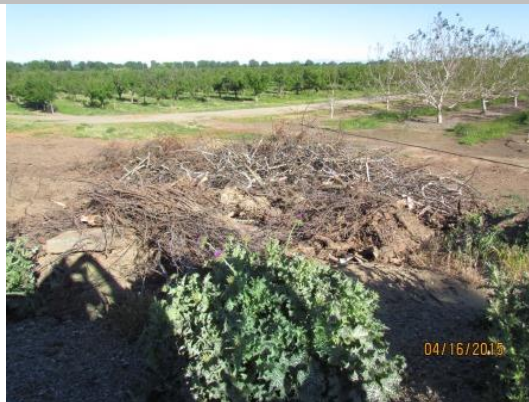
Photo 1 of 1 : SP_2018_NA0019_81_21_20180305_00014.jpg

View of the prunings along landside toe.

LM Start	3.66	Rating **	M	Issue No.	21
LM End	3.66	Issue Type +	En	Location *	LS
Category	Earthen Levee			GPS Latitude/Longitude	
				Start	End
Item	Encroachments			40.055735 °	40.055735 °
				-122.129445 °	-122.129445 °
DWR ID	DWR_NA0019_04_s_2015_21				
Comment Code					
PR : Prunings					
Inspector Comment					
Remove the prunings from the landside toe.

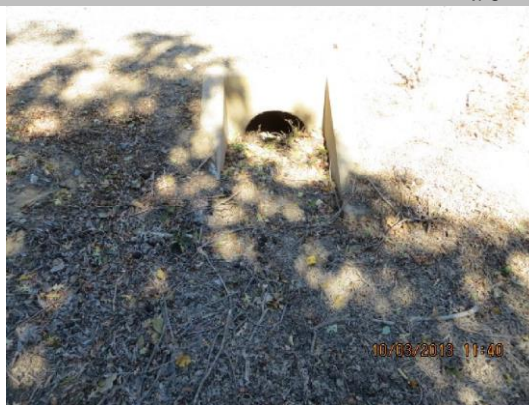
LM Start	0.11	Rating **	A/W	Issue No.	20
LM End	0.11	Issue Type +	Ma	Location *	
Category	Supplemental			GPS Latitude/Longitude	
				Start	End
Item	DWR UCIP LMA Responsibility			40.051702 °	40.051702 °
				-122.189922 °	-122.189922 °
DWR ID					
Comment Code					
Inspector Comment					
FS_ID:21744					
DS_ID:20799					
EP_NO: N/A					
Repair Type: No Action Needed					
Crossing Status: Found					
UCIP Comments:					
FIELD_STRUCT_DESC: 24-inch corrugated metal drainage pipe through the levee, 5.4 feet below the crown. Flap gate on the waterside (WS) end. Concrete U-shaped headwalls on the WS and landside (LS) ends. [Additional Reference(s): DWR Levee Log, 1992. USACE Sacramento O&M Manual 510, April 1963, (HLM 0.11) Drawing No. 50-4-3622].					
FS Date: 10/3/2013

Concrete headwall on LS toe.

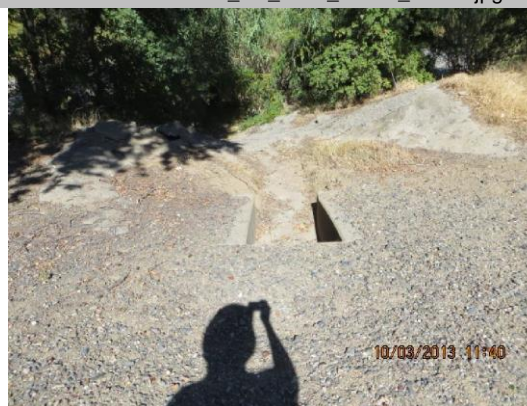
Photo 3 of 3 : UCIP_SP_2018_21744_36943.jpg

Concrete U-shaped headwall on WS slope.

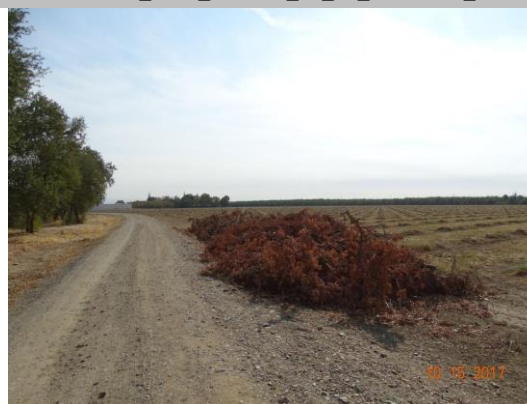
Photo 1 of 1 : SP_2018_NA0019_82_15_20180305_00006.jpg

LM Start	0.18	Rating **	M	Issue No.	15
LM End	0.18	Issue Type +	En	Location *	LS
Category	Earthen Levee			GPS Latitude/Longitude	
				Start	End
Item	Encroachments			40.051277 °	40.051277 °
				-122.188905 °	-122.188905 °
DWR ID	DWR_NA0019_05_f_2017_15				
Comment Code					
PR : Prunings					
Inspector Comment					
Remove the prunings from the landside toe.

View of the prunings along the landside toe.

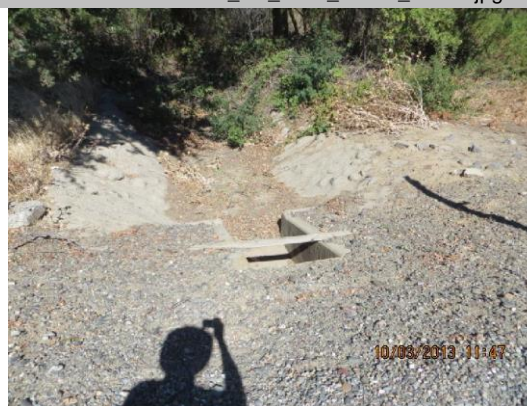
Photo 1 of 3 : UCIP_SP_2018_41124_36953.jpg

LM Start	0.50	Rating **	M	Issue No.	21
LM End	0.50	Issue Type +	Ma	Location *	
Category	Supplemental			GPS Latitude/Longitude	
				Start	End
Item	DWR UCIP LMA Responsibility			40.050585 °	40.050585 °
				-122.182972 °	-122.182972 °
DWR ID					
Comment Code					
Inspector Comment					
FS_ID:41124 DS_ID:20801 EP_NO: N/A Repair Type: Non-Urgent Crossing Status: Found UCIP Comments: Debris inside pipe at WS toe needs to be removed as it may prevent proper operation of the flapgate. FIELD_STRUCT_DESC: 24-inch corrugated metal drainage pipe through the levee, 5.2 feet below the crown. Flap gate on the waterside (WS) end. Concrete U-shaped headwalls on the WS and landside (LS) ends. [Additional Reference(s): DWR Levee Log, 1992. USACE Sacramento O&M Manual 510, April 1963, (HLM 0.51) Drawing No. 50-4-3622]. FS Date: 10/3/2013

Concrete headwall on WS toe.

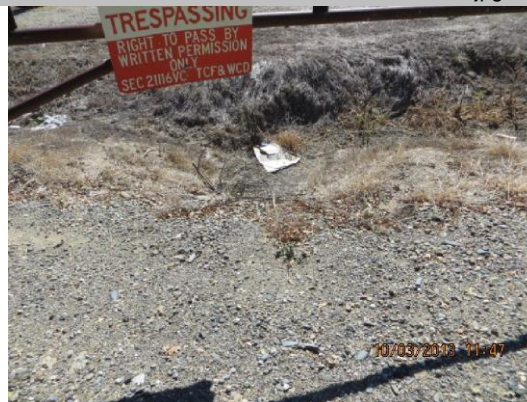
Photo 2 of 3 : UCIP_SP_2018_41124_36952.jpg

Inlet at LS toe.

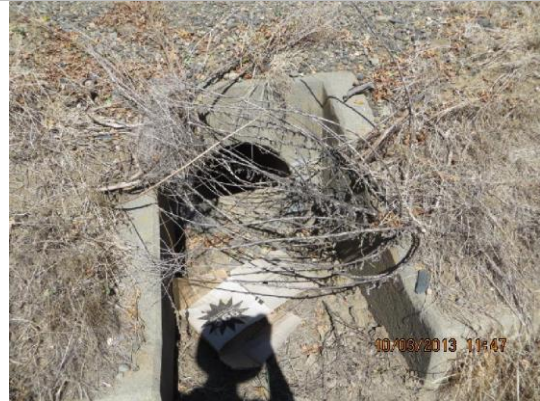
Photo 3 of 3 : UCIP_SP_2018_41124_36951.jpg

LM Start	0.50	Rating **	M	Issue No.	21 (cont)	
LM End	0.50	Issue Type +	Ma	Location *		
Category	Supplemental			GPS Latitude/Longitude		
				Start	End	
Item	DWR UCIP LMA Responsibility			40.050585 °	40.050585 °	
				-122.182972 °	-122.182972 °	
DWR ID						
Comment Code						
Inspector Comment						
FS_ID:41124 DS_ID:20801 EP_NO: N/A Repair Type: Non-Urgent Crossing Status: Found UCIP Comments: Debris inside pipe at WS toe needs to be removed as it may prevent proper operation of the flapgate. FIELD_STRUCT_DESC: 24-inch corrugated metal drainage pipe through the levee, 5.2 feet below the crown. Flap gate on the waterside (WS) end. Concrete U-shaped headwalls on the WS and landside (LS) ends. [Additional Reference(s): DWR Levee Log, 1992. USACE Sacramento O&M Manual 510, April 1963, (HLM 0.51) Drawing No. 50-4-3622]. FS Date: 10/3/2013

Concrete headwall at LS toe.

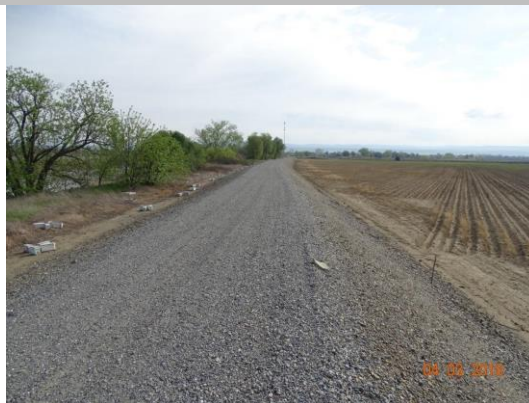
Photo 1 of 1 : SP_2018_NA0019_82_16_20180405_00020.jpg

LM Start	1.57	Rating **	A	Issue No.	16
LM End	1.57	Issue Type +	Ma	Location *	LS
Category	Earthen Levee			GPS Latitude/Longitude	
				Start	End
Item	Vegetation			40.050808 °	40.050808 °
				-122.164423 °	-122.164423 °
DWR ID	DWR_NA0019_05_s_2018_16				
Comment Code					
V1 : Control annual grass and weeds on the levee slopes and easements.					
Inspector Comment					
The vegetation was removed from both slopes.

View of no vegetation on both slopes.

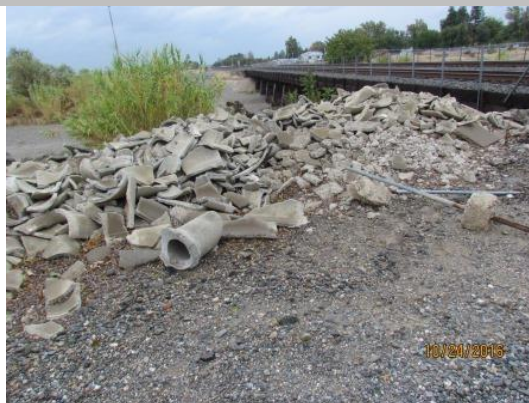
Photo 1 of 1 : SP_2018_NA0019_82_14_20180305_00005.jpg

LM Start	2.41	Rating **	M	Issue No.	14
LM End	2.41	Issue Type +	En	Location *	LS
Category	Earthen Levee			GPS Latitude/Longitude	
				Start	End
Item	Encroachments			40.051274 °	40.051274 °
				-122.150113 °	-122.150113 °
DWR ID	DWR_NA0019_05_f_2016_14				
Comment Code					
DE : Debris					
Inspector Comment					
Pile of broken concrete pipes on the waterside.

View of the broken pipes along the waterside slope.

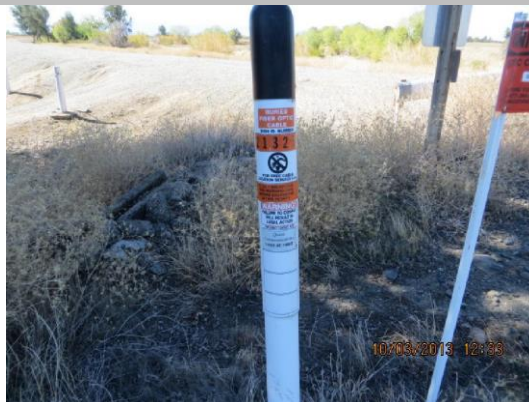
Photo 2 of 2 : UCIP_SP_2018_23052_39136.jpg

Fiber optic line markers on LS shoulder.

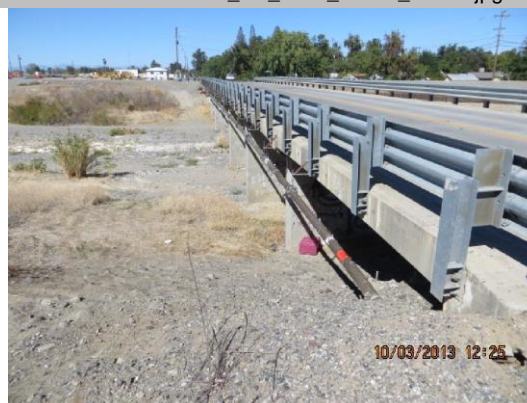
Photo 3 of 3 : UCIP_SP_2018_23044_39102.jpg

LM Start	2.47	Rating **	M	Issue No.	23 (cont)	
LM End	2.47	Issue Type +	En	Location *		
Category	Supplemental			GPS Latitude/Longitude		
				Start	End	
Item	DWR UCIP Field Study			40.051667 °	40.051667 °	
				-122.149033 °	-122.149033 °	
DWR ID						
Comment Code						
Inspector Comment						
FS_ID:23044 DS_ID:24693 EP_NO: N/A Repair Type: Non-Urgent Crossing Status: Found UCIP Comments: No permit identified for this crossing. FIELD_STRUCT_DESC: 4-inch steel gas pipeline through the levee, 2.5 feet below the crown. Pipe visible on upstream side of bridge. FS Date: 10/3/2013

Gasline on upstream side of bridge.

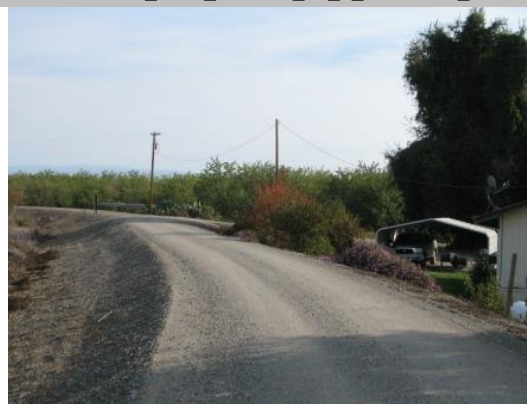
Photo 1 of 1 : SP_2018_NA0019_82_2_20180305_00001.jpg

LM Start	2.65	Rating **	M	Issue No.	2
LM End	2.70	Issue Type +	En	Location *	LS
Category	Earthen Levee			GPS Latitude/Longitude	
				Start	End
Item	Vegetation			40.051778 °	40.052243 °
				-122.145745 °	-122.144825 °
DWR ID	DWR_NA0019_05_s_2012_2				
Comment Code					
V6 : Landscaping					
Inspector Comment

View of the landscaping along the slope.
